**INCREASING AIRPORT OPERATION SAFETY BASED ON UPDATED OR
ENHANCED AIRPORT PAVEMENT MARKINGS: A CASE STUDY**

PAPER 09-2020

This paper presents the pavement markings implementations at Kaousiung International Airport (KHH), Taiwan as case study in relation to airport operation safety. The two-year marking projects that focused on updating or improving the identified markings issues consisted of relocating touchdown zone markings, redeveloping taxiway markings, and redesigning and improving apron markings. Each update or improvement project was evaluated to ensure compatibility with International Civil Aviation Organization (ICAO) standards prior to construction. The objective of this paper is to present the markings issues identified at KHH, discuss how those issues came about, and explain how the airport authorities dealt with those issues. Through the comprehensive review and construction efforts in pavement markings, the updated or improved configurations of pavement markings at KHH meet the ICAO standards, addressed previously identified issues, as well as increased the aircraft operation safety and ground movement safety.

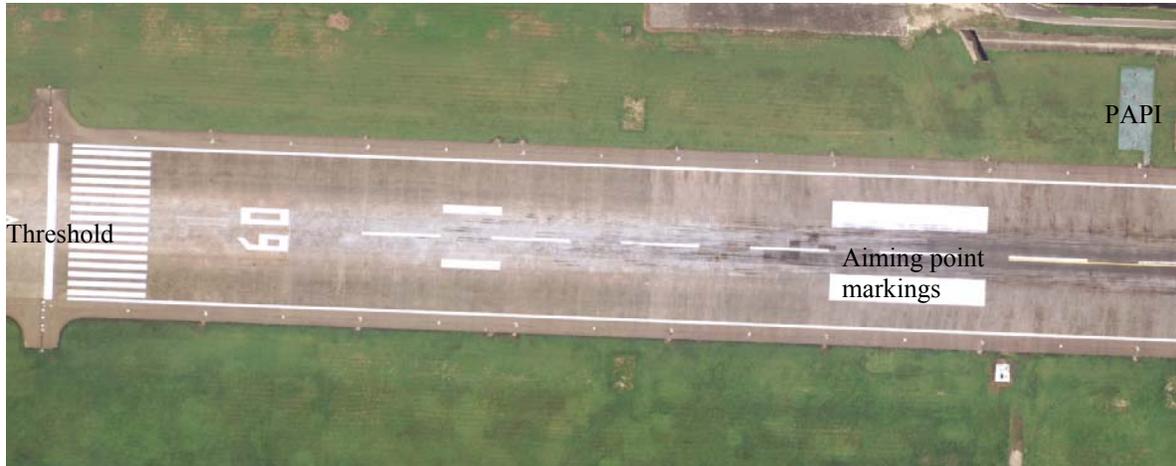
FIGURE 2a Geometric relationship between aiming point markings and the PAPI on the 09 runway direction at KHH

According to the field investigation findings, the position of aiming point markings was located 110 m ahead of the PAPI system at the 09 runway direction. The PAPI system was located 21 m ahead of the aiming point markings at the 27 runway direction. Thus, the 09 runway direction was selected to study the relationship between the potential risks and relocation of aiming point markings.

minimum wheel clearance requirement. Thus, the existing location of PAPI appears to be appropriate for visual cues during aircraft landings. After assessing the results from the sensitivity analysis, the KHH authorities decided to relocate the aiming point markings at both runway 09 and 27 ends to keep aiming point markings aligned with the PAPI system. The relocation project of touchdown zone markings took 7 consecutive days to remove and repaint aiming point markings and corresponding touchdown zone markings at runway 09 and 27 ends.

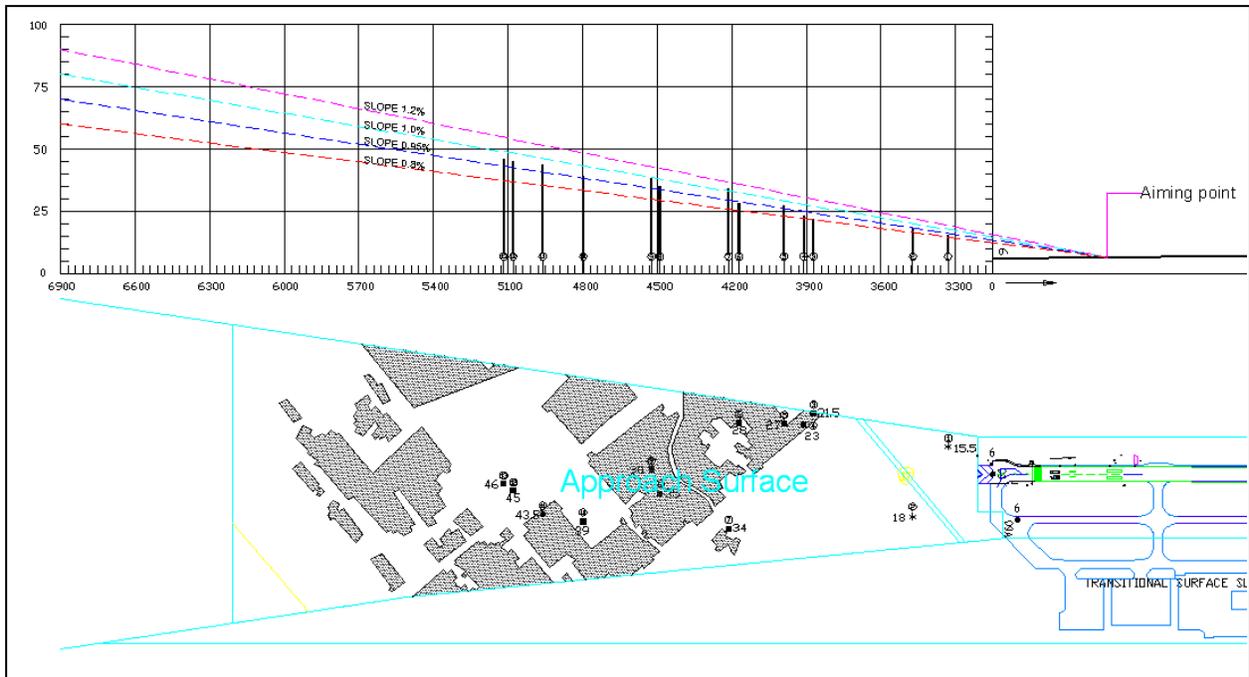
FIGURE 3 Visual Approach Geometry Evaluation

As shown in Figure 3, the analysis indicates that out of four aircraft approach boundary envelopes, the critical slope was about 1.0 %. At this slope the angles of alpha and beta did not exceed the normal slope angle of 3 degrees and still maintained sufficient vertical distances above the elevations of obstacles within the approach surface.

Note: numbers represent locations of features that present vertical clearance issues

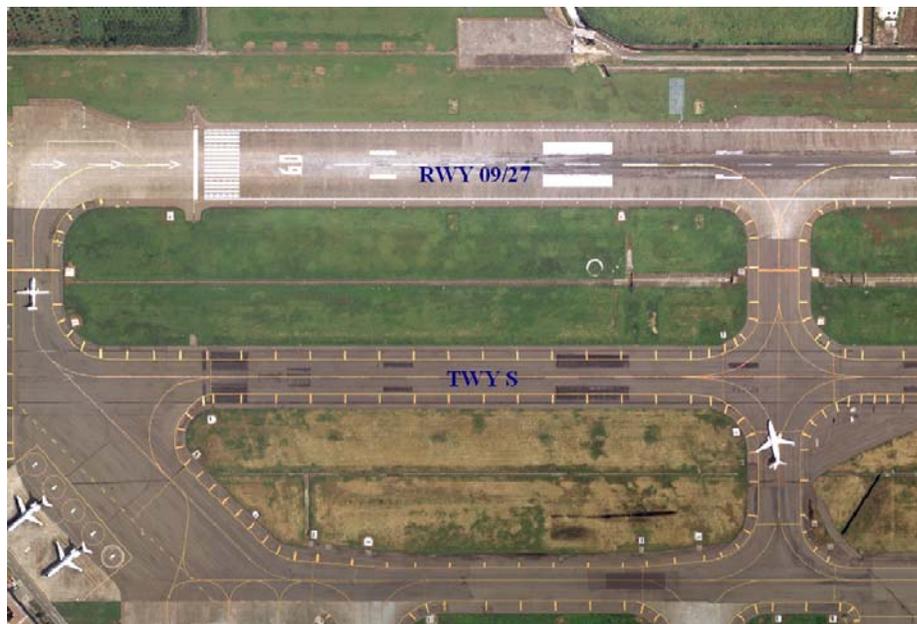
FIGURE 4b Completion of TWY S marking redevelopment

Note: RWY 09R/27L was renamed to Taxiway S as of January, 2003

1. Runway 09R/27L was renamed as Taxiway S so as to provide clear airport configurations (Runway 09/27, Taxiway A, B, C,...S, etc.)
2. Improper pavement markings on Taxiway S were replaced with updated pavement markings for use of taxiway activities.

3. The width of Taxiway S was reduced from 60 m to 23 m since having a width of 60 m might confuse pilots when approaching the aircraft to the landing runway. A reduced width of 23 m associated with the transverse stripe markings and corresponding edge lighting systems were designed, which would make Taxiway S a normal taxiway for aircraft taxiing operations.
4. Existing holding bays, runway-holding positions, intermediate holding positions and road-holding positions (pattern B) were replaced with updated markings (pattern A) in order to suit the geometric conditions along perpendicular taxiways and cargo apron. The clearance distance between taxiway centerline to the nearest object was determined to be 47.5 m as required by the ICAO and IATA standards (48.5m by the FAA). For details of pattern B and A, please refer to the ICAO standards (2).

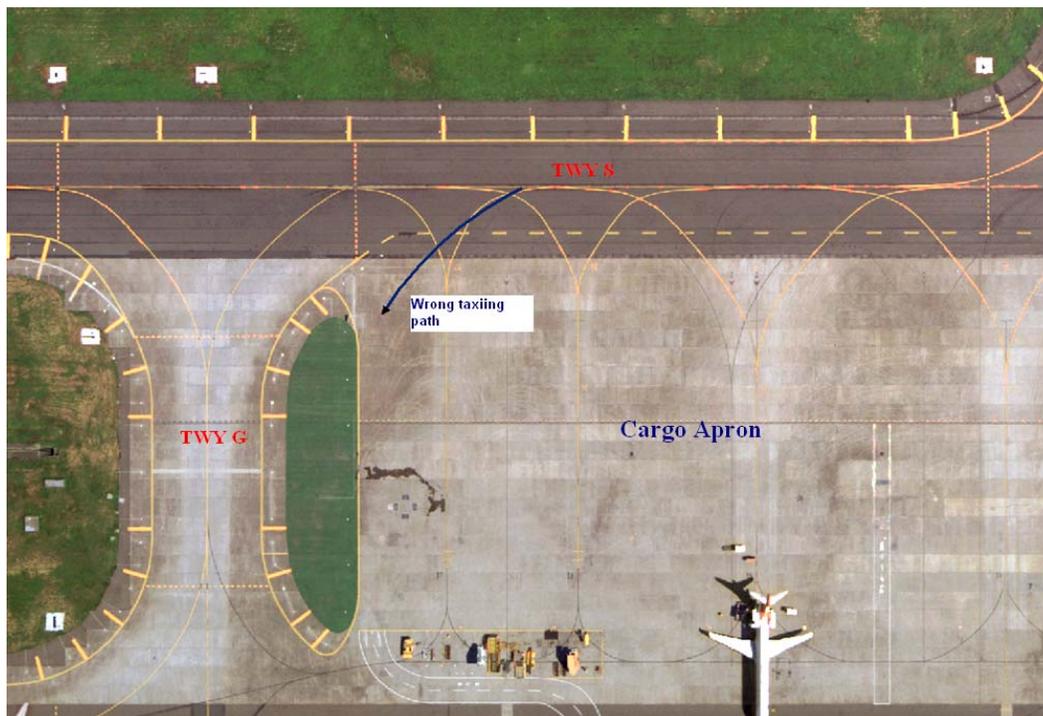
FIGURE 4c Before improvements at the intersection of TWY S, G, and cargo apron

An issue was found at the intersection of Taxiway S, Taxiway G, and cargo apron (Figure 1). The Division of Operation received complaints from pilots that the markings on the intersection of Taxiway S and G were too complex when operating aircraft to this area during low visibility weather conditions. Two ground incidents where passenger airplanes mistakenly made a wrong turn to the cargo apron at this section were reported (Figure 4c). Although, the marking configurations at this area were originally designed in accordance with the ICAO

standards, the performance of pavement markings at this area did not work effectively in directing taxiing airplanes to turn to Taxiway G. Based on the marking review, the simple nose-wheel lead-in lines were placed in cargo apron and the intersection of Taxiway S and G (Figure 4c). The reflective grass beans were also added to all of pavement markings at the airport. The pavement marking configurations of this area were appeared to be more complex for aircraft operations under low visibility conditions, particularly at night. To enhance aircraft operation safety, improvements to the marking configurations were needed.

Airfield visits were scheduled to identify possible reasons for the ground incidents as previously described. As shown in Figure 4c, the nose-wheel-lead-in lines for visual aids to cargo apron showed complex patterns (cross over each other). Such patterns of lead-in lines were originally designed to match the existing taxiway centerline. It was determined that these complex built-on markings were responsible for the pilots' confusion. It appeared that pilots might mistakenly take a left turn earlier, before moving to the intersection (Figure 4c). This was particularly critical at night or during low visibility. The span distance of lead-in lines between the apron and the Taxiway G was measured at 55 m. In addition, pavement markings crossed over with the neighboring line. From the eye positions of the pilots, such marking configurations were not significant enough in helping pilots distinguish the exact taxiing lead-in lines towards the Taxiway G.

1. Existing nose-wheel-lead-in lines were replaced with offset nose-wheel lead-in lines. This offset marking pattern was designed to significantly separate two operation areas (e.g. cargo apron and intersection of TWY S and G) so that the taxiway centerline markings to Taxiway G and offset lead-in lines to cargo apron are well-defined. Pilots would not confuse the maneuvering positions while operating aircraft to this area. Offset lead-in lines were conducted in compliance with ICAO Aerodrome Design Manual Part 4, Section 2.3.5 (2).

2. Place geographic position markings (surface indication signs) on the pavement surface and each offset nose-wheel lead-in line to assist pilots in observing the visual cues when making a left turn to the Taxiway G. Geographic position markings were installed in front of the intersection on the surfaces of the Taxiway S and G. This design was intended to help pilots identify the position of taxiing aircraft during low visibility conditions. It should be noted that the information of geographic position markings are mentioned in ICAO standards only for distinguishing runway entrance indication. However, specifications of geographic position markings on taxiways and aprons are described in the FAA AC 150/5430 standard (4). Thus, the KHH engineers applied the FAA standard in the improvement project of pavement markings to make up the gap of geographic position markings information.

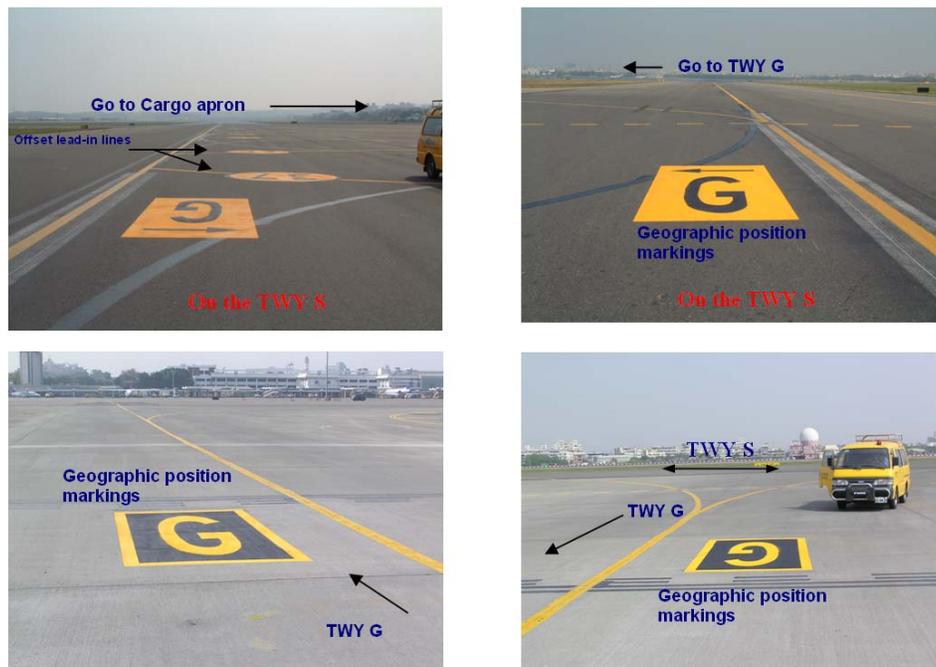
FIGURE 4d After completion of marking improvements at the intersection of TWY S, G and entrance to cargo apron

Comparisons between pre and post marking improvements at KHH are shown in Figure 4c-d. Since completion of the marking improvements at the intersection of Taxiway S and G in 2003, no wrong-turning incident has been reported to the Division of Operation. This improvement helped the KHH authority receive positive reactions from pilots with respect to the efforts on significant and well-defined marking improvements along the Taxiway S and at the intersection of Taxiway S and G.

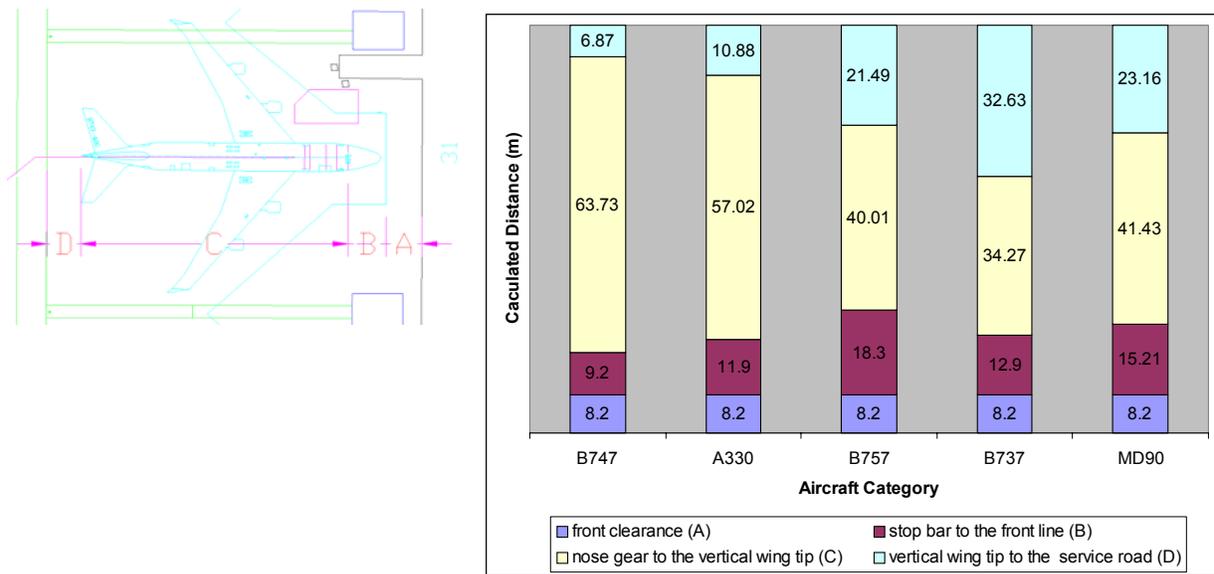
FIGURE 5a Sensitivity analysis for equipment restraint line installations in apron parking stands

In advance of locating safety zone markings for aircraft and ground equipment movements, a sensitivity analysis was performed to ensure clear space between an aircraft and the nearest object (e.g. terminal buildings, service road, neighboring aircraft, etc.). The purpose of the sensitivity analysis is to examine the potential risks due to the relocation of the pavement markings and installation of new markings in the apron areas. Figure 5a shows the analysis results of restraint line installation for five categories of aircraft, B747, A330, B757, B737, and MD 90. The principle of the sensitivity analysis is to ensure that the minimum clearance of 7.5 m at each side of parked aircraft (aircraft's nose, both sides of wing tip, and vertical wing tip) to any adjacent object is maintained; otherwise compliant adjustments need to be made. As shown in Figure 5a, a horizontal clearance of 6.87 m from the B747's vertical wing tip to the edge of the service road was needed. However, this marking plan was in disagreement with the standards. Therefore, the front clear distance of 8.2 m (parameter A in Figure 5a) at the B747 aircraft parking stand was adjusted to 7.5m so that the horizontal distance of 6.87 m was increased to 7.77 m. This adjustment made the minimum clearance requirement in compliance with the ICAO standards at front and end sides of B747 aircraft.

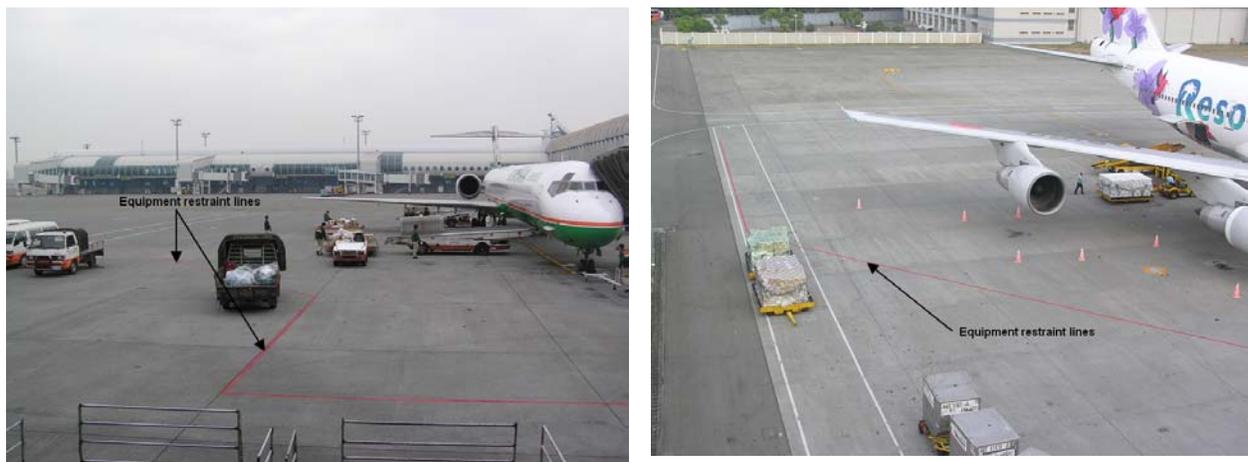
FIGURE 5b Well-defined safety zones help increase apron management efficiency at KHH

After completion of restraint lines and other visual aid markings (e.g. geographic indication marking for each aircraft parking position), the safety zones in the international apron and other apron areas have been well defined and provide ground service employees with clear indications for loading and unloading areas (Figure 5b). Such marking enhancements not only can meet the amendment, but also help airport operators effectively execute apron safety policies.

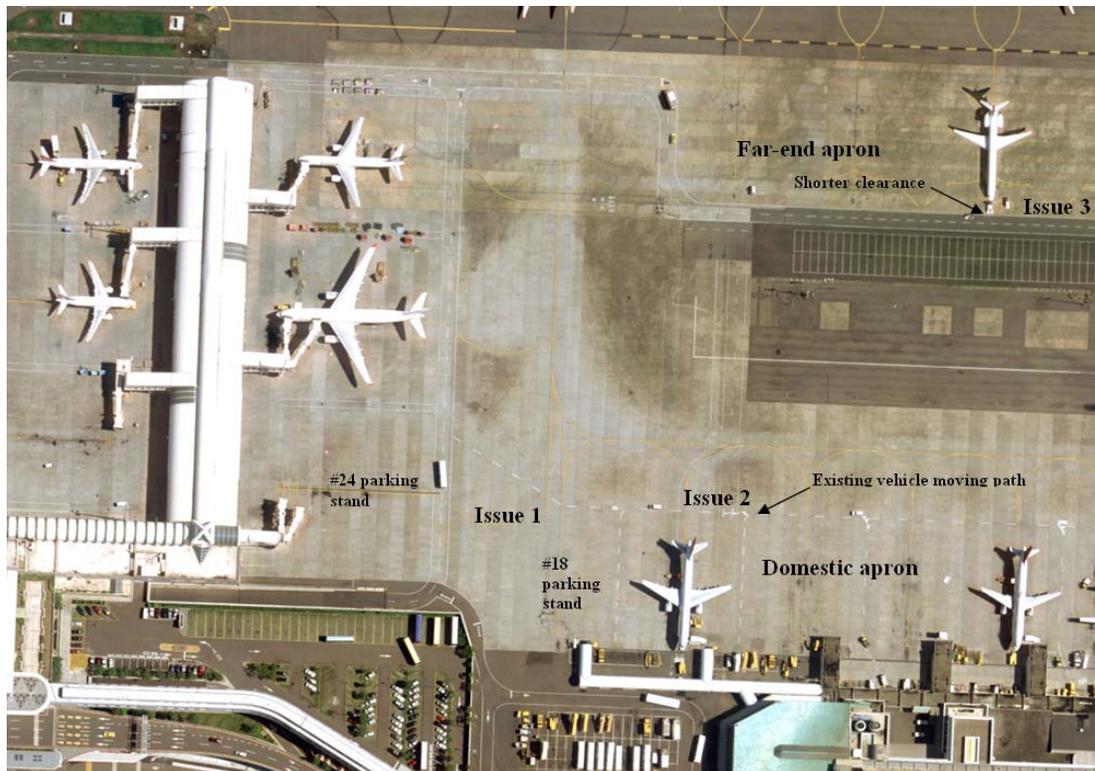
FIGURE 6a Identified issues in the far-end apron and domestic aprons

1. The first issue was located at the aircraft movement interaction between the international apron stand #24 and domestic apron stand #18. Due to limited clearance between these two stands, only one aircraft was allowed to park at either #24 or #18 parking position (Figure 6a). In past years, this limitation decreased availability of parking positions and parking position assignment policies for arrival aircraft, particularly at peak hours.

2. The second issue was observed in the domestic apron area. Service road layout was not clearly planned for ground equipment movements. It was noticed that ground mobile equipment traveled through aircraft lead-in lines delivering cargo and other items (Figure 6a). Such situations created an unsafe operating environment. Installing a new service road in the domestic apron will be the priority used to address this issue. The challenging task was the limitations of existing geometric conditions (surrounding parking lots and other equipment parking areas) for future service road extension.

3. The third issue was identified to be shorter clearances between aircraft parking stands and the service road at the far-end apron (Figure 6a). Measured dimension of 5.8 m between the nose of the parked aircraft and the edge of the service road did not meet the minimum clearance of 7.5 m. Ground mobile equipment such as passenger stair equipment moving on the road could potentially intrude the safety zone and possibly hit the parked aircraft's nose under low visibility conditions or at night.

To address these three identified issues, a marking improvement plan was proposed that included relocations of the existing service road 3.5 m south, building a new service road parallel to the existing road, and dimension rearrangements of existing lead-in lines in the domestic apron (Figure 6b). Prior to construction, a sensitivity analysis was initiated to 1) calculate the spans between maneuvering/parked aircraft and the nearest object, and 2) determine parking limitation information for different aircraft types to optimize utilizations of aircraft parking stands. The contents of the improvement plan are summarized as follows and illustrated in Figure 6b:

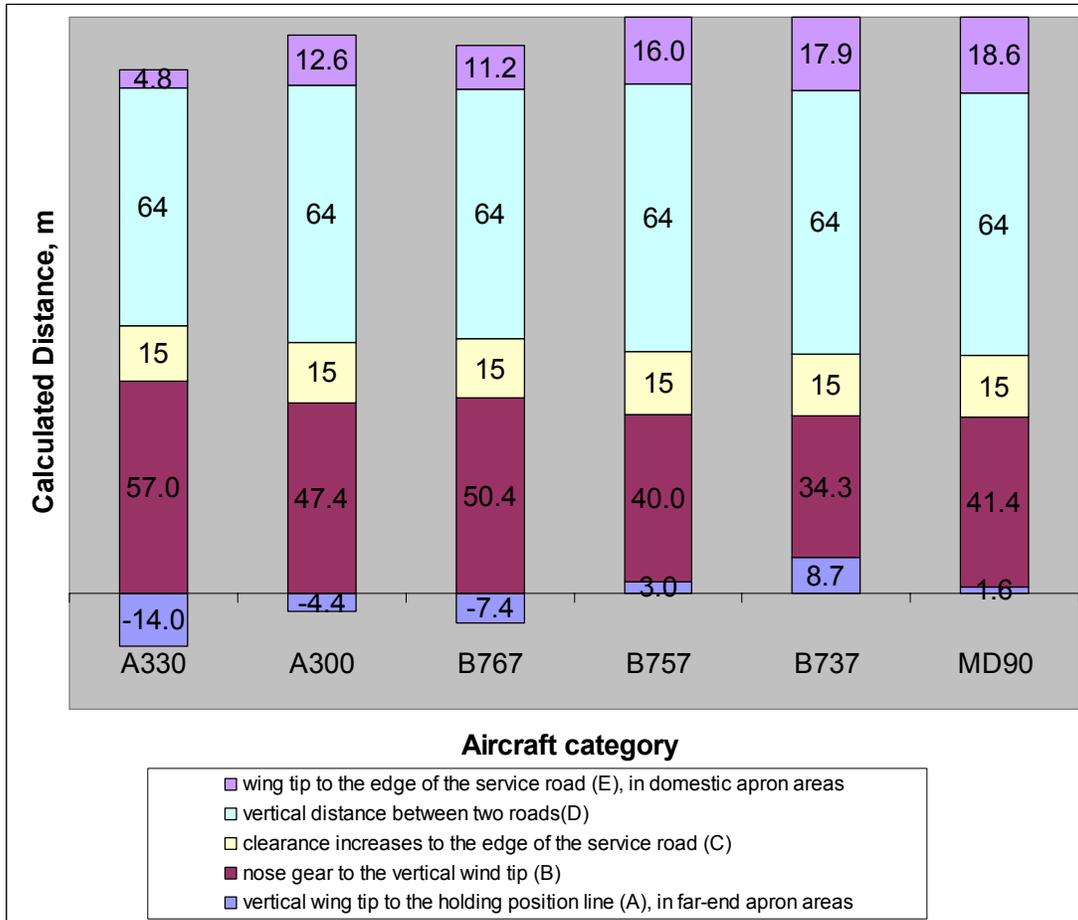
FIGURE 7 Sensitivity analysis for service road installations and aircraft movement path adjustments in the far-end and domestic apron areas

During the sensitivity analysis, the nose gear path of a moving aircraft was assumed to be 1 m offset between the aircraft taxiing centerline used to model the critical scenarios for each aircraft category including A330, A300, B767, B757, B737, and MD90. This assumption is based on observations in the apron areas. Thus, the one-meter offset of taxiing path from the centerline could result in conservative estimates for the calculations of the wing tip clearance (parameter E in Figure 6b). In addition, in the far-end apron areas, the distance between the holding position lines to the taxiway centerline needed to be kept at least 47.5 m according to the ICAO. Under the principles of clearance limitations at both far-end and domestic aprons, a simulation was performed to determine allowable distances for each aircraft type during the processes of service road installations, and dimension rearrangements of lead-in lines. The criteria for a successful plan is that the calculated allowable distance between each aircraft's wing tip must be greater than the minimum clearance of 7.5 m; otherwise dimension adjustments of lead-in lines and service roads needed to be achieved. The calculated results are depicted in Figure 7.

After relocation of the existing service in the far-end apron, the clearance distance between the nose of a parked aircraft and the edge of the service road was increased to 8 m. This design met the requirement. However, it was observed that the back edges of the B330, B300, and B767 aircraft exceeded the holding position line in the far-end apron. Thus, the allowed maximum demanding aircraft type was determined to be a B757 or other aircraft code D defined by the ICAO or aircraft design group IV defined by the FAA.

2. Wing tip clearance calculations between the aircraft moving boundary line to the edge of the new service road were described in Figure 7 in the row of parameter E. It is observed that except an A330, other demanding aircraft types meet the requirements of minimum clearance, 7.5m. However, such demanding aircraft should be further evaluated with results of the aircraft parking position metrics depicted in Table 3 to determine the required aircraft types allowed in the domestic apron.
